Piston damages

Recognising and rectifying

Date 08.04
1. Edition
Part-No. 50 003 973-02

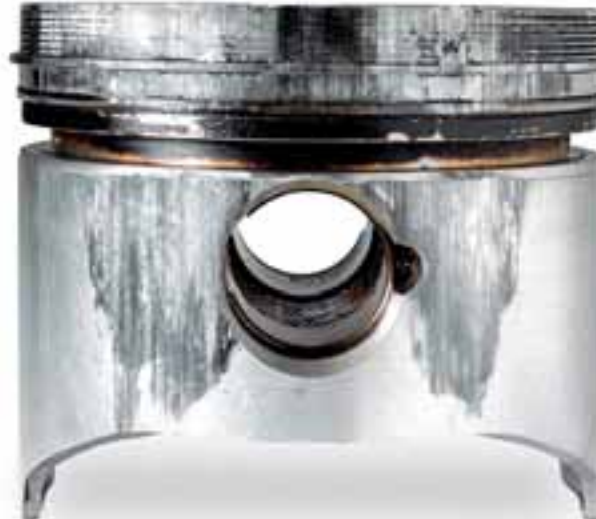
Fig. 1

Seizure marks at an offset of approximately 45° to the piston pin axis which are found both on the pressure side and on the counterpressure side are characteristic of this type of damage. The surface at the seizures gradually changes from highly polished pressure areas to relatively smooth, darkly discoloured areas of wear caused by rubbing. The piston pin displays blue tempering colours; which indicates in this case that the piston pin bed must have become hot due to insufficient clearances or a lack of oil.

This damage is caused when the area around the piston pin heats up excessively. As this area of the piston is quite stiff, this causes an increased thermal expansion in the area and a restriction of the clearances be-

However, at the transition to the more rigid piston pin bore the material then comes to bear with greater force on the cylinder wall, which ultimately causes the oil film to be forced out and the piston to rub.

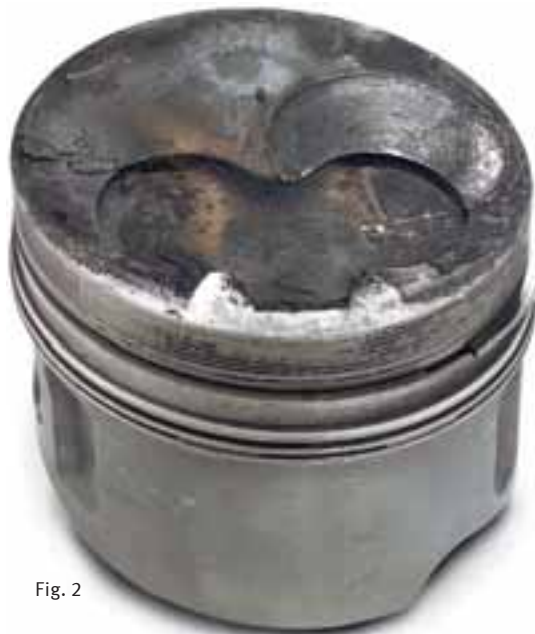
Fig. 2

On the piston shown in Fig. 2, an imprint of the swirl chamber can be seen on the front edge of the crown, and a strong imprint of the valve can be seen on the right-hand side of the crown. This means that, as well as the swirl chamber, a valve has also made contact with the piston crown during operation, and the valve has gradually dug itself into the piston crown (see Fig 3). First indicators of rubbing marks due to a lack of lubrication are evident on the piston skirt (see Fig. 4).

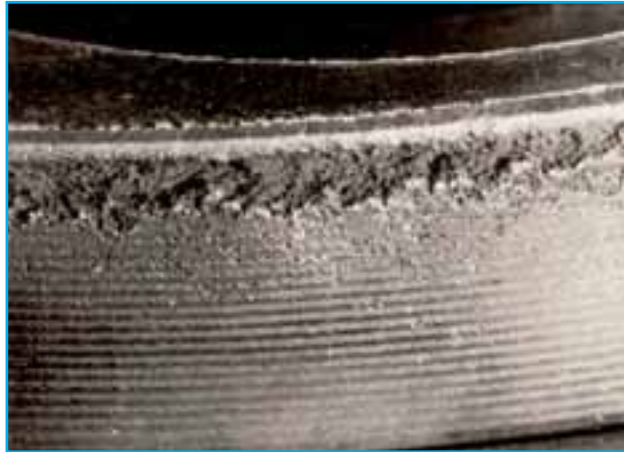
Fig. 1

The piston top land shows areas where material has been carried away in an erosion-type process (see Fig. 1). This removal of material often continues on the surface of the piston crown (see Fig. 2). There are not necessarily any seizure marks or other damage to the piston.

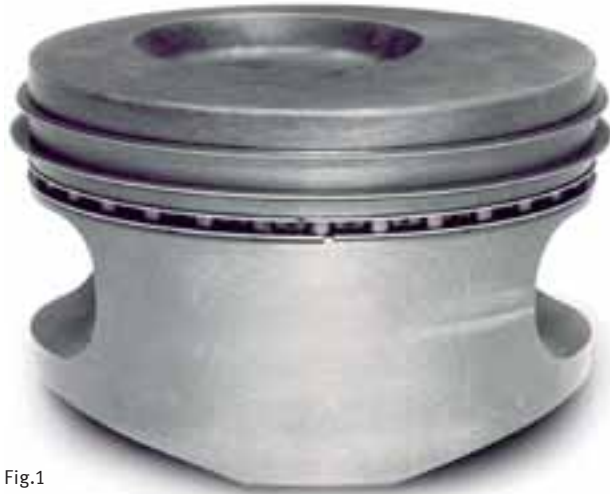
Fig. 1

The rings do not display any visible or measurable wear. No signs of wear are evident on the pistons either (Fig. 1). In this case, the oil scraper ring is a 3 piece oil control ring comprising the expander spring and the two blade rings. Both of the ends of the expander spring should normally be flushed against each other. In this case the expander spring had been installed incorrectly, and the last segment overlapped at the joint (Fig. 2).

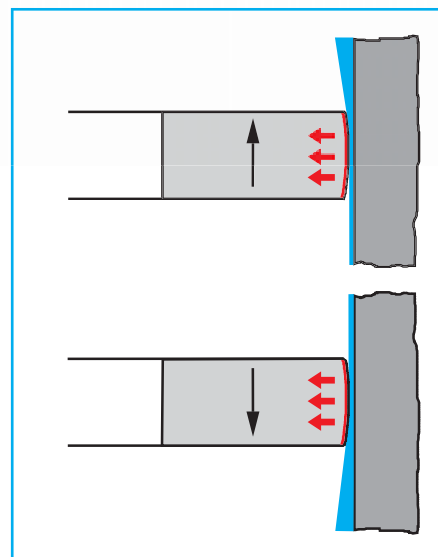
Fig. 2

during the upward/downward motion of the piston and are lifted slightly off the cylinder running surface. In this way, increased quantities of lubricating oil reach the combustion chamber where they are then burned.
