Piston damages

Recognising and rectifying

Date 08.04
1. Edition
Part-No. 50 003 973-02

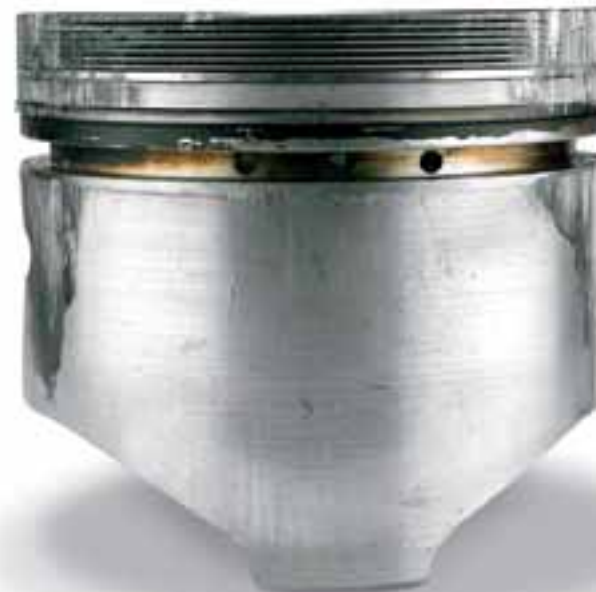
Fig. 2

Seizure marks at an offset of approximately 45° to the piston pin axis which are found both on the pressure side and on the counterpressure side are characteristic of this type of damage. The surface at the seizures gradually changes from highly polished pressure areas to relatively smooth, darkly discoloured areas of wear caused by rubbing. The piston pin displays blue tempering colours; which indicates in this case that the piston pin bed must have become hot due to insufficient clearances or a lack of oil.

This damage is caused when the area around the piston pin heats up excessively. As this area of the piston is quite stiff, this causes an increased thermal expansion in the area and a restriction of the clearances be-

However, at the transition to the more rigid piston pin bore the material then comes to bear with greater force on the cylinder wall, which ultimately causes the oil film to be forced out and the piston to rub.

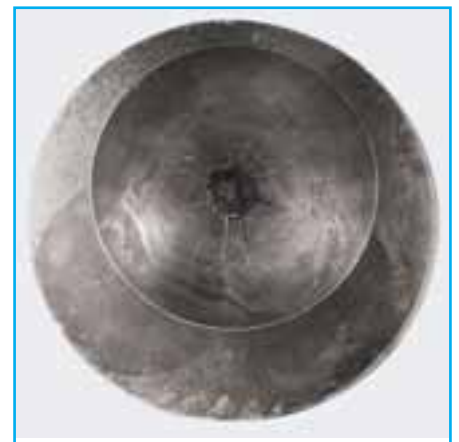
In the areas where before the material was buckled and forced away, there is now suddenly a shortage of material. This results in tensile stresses in this area which ultimately cause stress cracks (see Figs. 3 and 4). If in addition to the stresses resulting from the thermal overload there are also superimposed stresses caused by warping of the piston pin, then in some cases the stress cracks can turn into a much larger major crack which causes complete breakage and failure of the piston.

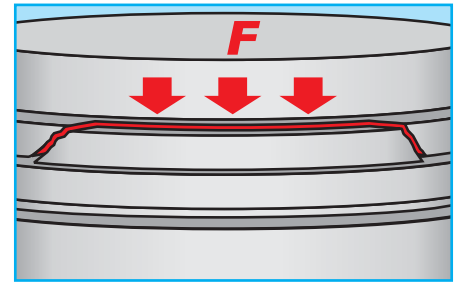
During installation, the piston was knocked in rather than being slid in, because the piston rings were not correctly compressed or unsuitable tools were used. In this case the ring lands fracture in the reverse direction as the pressure comes from below (Fig. 4), not from above as in the above case.

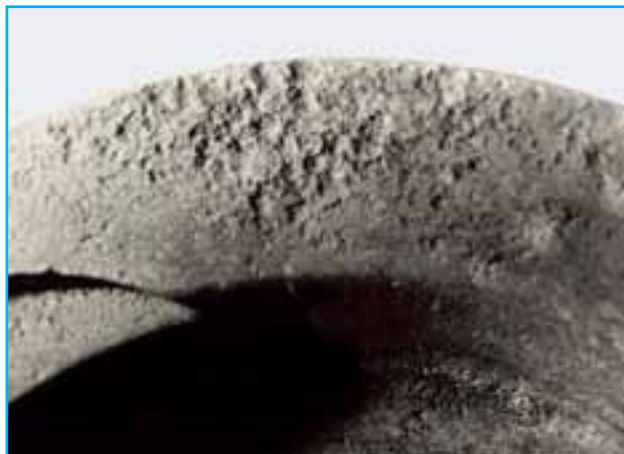
Fig. 2

The piston top land shows areas where material has been carried away in an erosion-type process (see Fig. 1). This removal of material often continues on the surface of the piston crown (see Fig. 2). There are not necessarily any seizure marks or other damage to the piston.

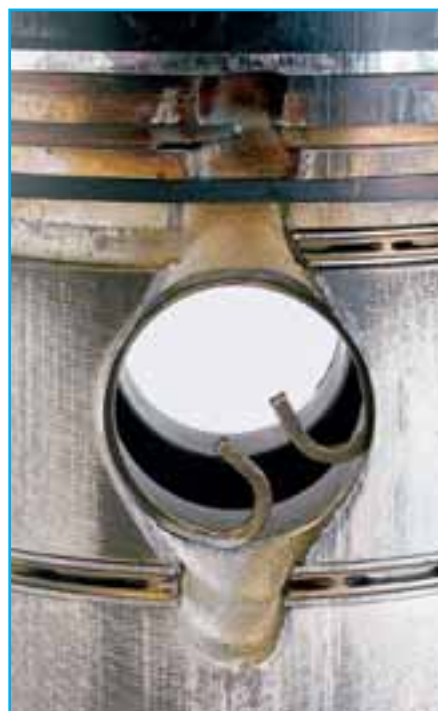
Fig. 2

On both sides of the piston, the end of the piston pin bore has suffered serious damage. In some places the damage reaches up as far as the ring zone (Fig. 1).

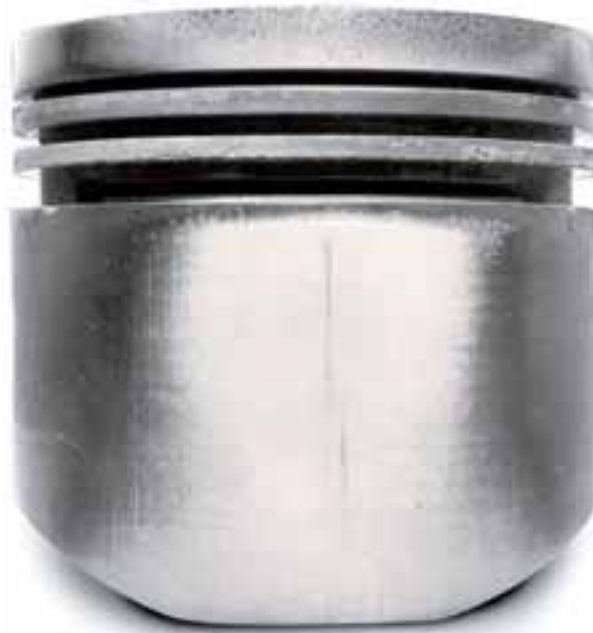
Fig. 1

One type of piston noise which is perceived as particularly annoying is caused by the piston crown striking

alternating sides of the cylinder running surface. Depending on the cause, the piston top land strikes either in

- Excessive installation clearances and hence poor guidance of the piston due to excessively large bored or honed cylinders.
- The installation direction was not observed for pistons with a piston pin axis offset.
- Tight connection between piston and conrod: As a result of the lack of clearance, the piston top land strikes against the cylinder running surface in the so-called tilt direction.

- Excessively narrow fit of the piston pin in the small-end bush (shrink-fit connecting rod). If fit of the piston pin is too tight in the connecting rod small end, then the connecting rod small end is deformed in the direction of the narrowest wall thickness when the piston pin is shrunk and installed. The connecting rod small end and the piston pin take on an oval form in the process.
- On shrink-fit connecting rods: restriction of the clearance between the piston pin and the piston caused by distortion of the piston pin as a result of the bore in the connecting rod small end no longer being geometrically round.
- Seized piston pin

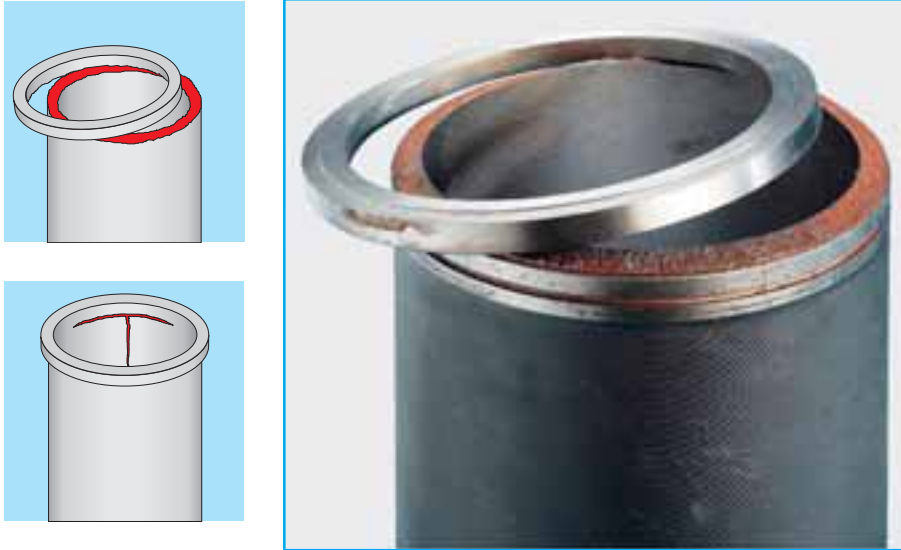
Fig. 1

The complete flange of the cylinder liner has been torn off (Fig. 1). The flange crack starts at the base of the lower edge of the liner flange and extends upwards under an angle of approx. 30°.

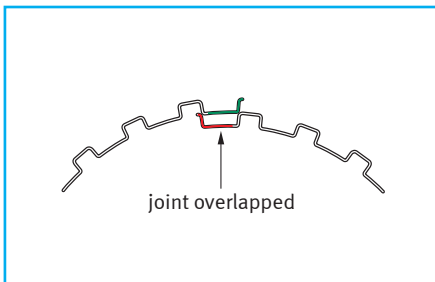
Fig. 2

The rings do not display any visible or measurable wear. No signs of wear are evident on the pistons either (Fig. 1). In this case, the oil scraper ring is a 3 piece oil control ring comprising the expander spring and the two blade rings. Both of the ends of the expander spring should normally be flushed against each other. In this case the expander spring had been installed incorrectly, and the last segment overlapped at the joint (Fig. 2).
